**SITE ASSESSMENT REPORT
FOR
JEFFERSON PROCESSING SITE
MINGO JUNCTION, JEFFERSON COUNTY, OHIO
TDD: S05-9903-008
PAN: 9M0801SIXX
DOCUMENT CONTROL NUMBER: START-05-23-050105**

January 31, 2000

**UNITED STATES ENVIRONMENTAL PROTECTION AGENCY
Emergency Response Branch
77 West Jackson Boulevard
Chicago, Illinois 60604**

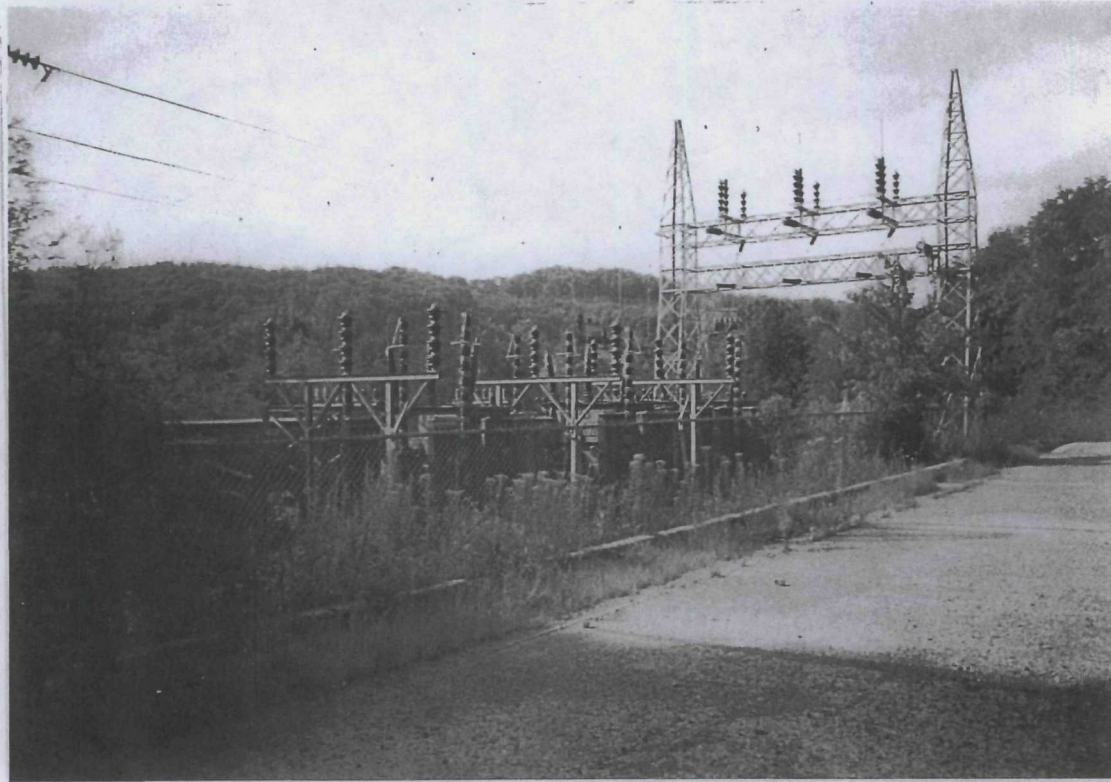
SITE: Jefferson Processing Site **TDD:** S05-9903-008 **PAN:** 9M0801SIXX **PHOTO:** 9
DIRECTION: South **DATE:** 8/12/99 **PHOTOGRAPHER:** Mayer
DESCRIPTION: A fenced electrical substation is located southwest of Plant J-1. The substation includes 3 transformers.

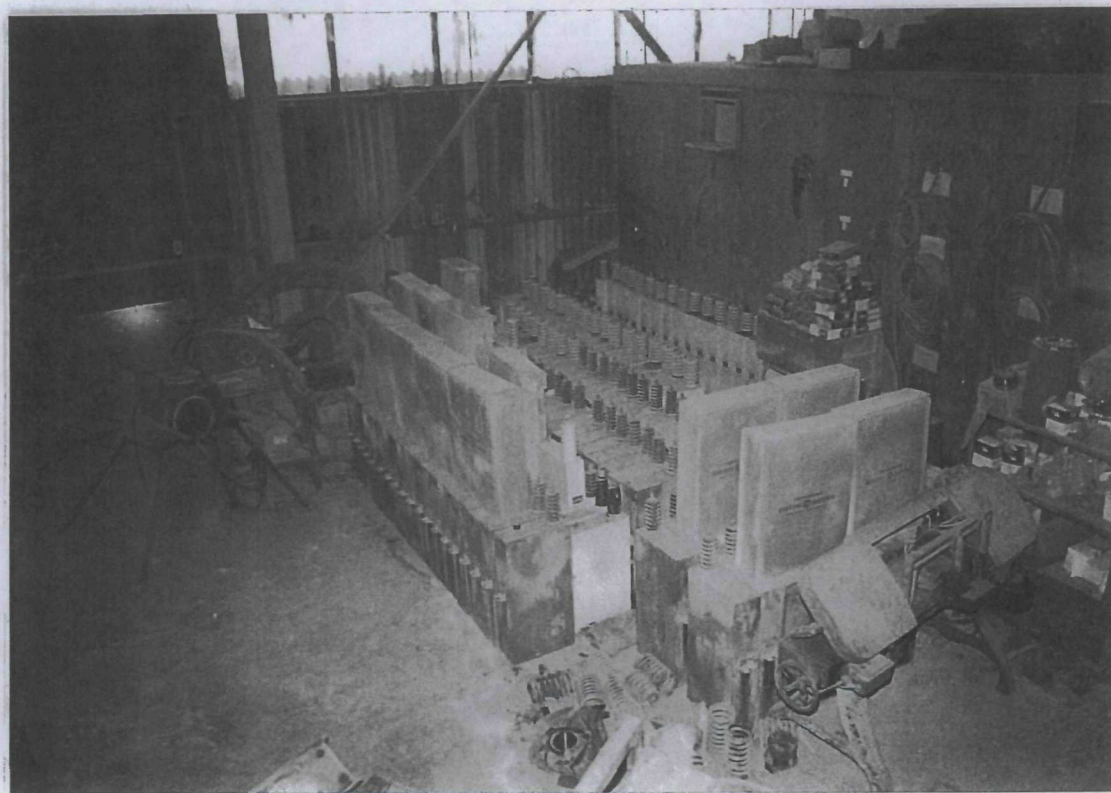
SITE: Jefferson Processing Site **TDD:** S05-9903-008 **PAN:** 9M0801SIXX **PHOTO:** 10
DIRECTION: South **DATE:** 8/11/99 **PHOTOGRAPHER:** Mayer
DESCRIPTION: Approximately 159 capacitors which had been found around the site have been staged in a room on the first floor of Plant J-1. The room is located on the southeast portion of Plant J-1.

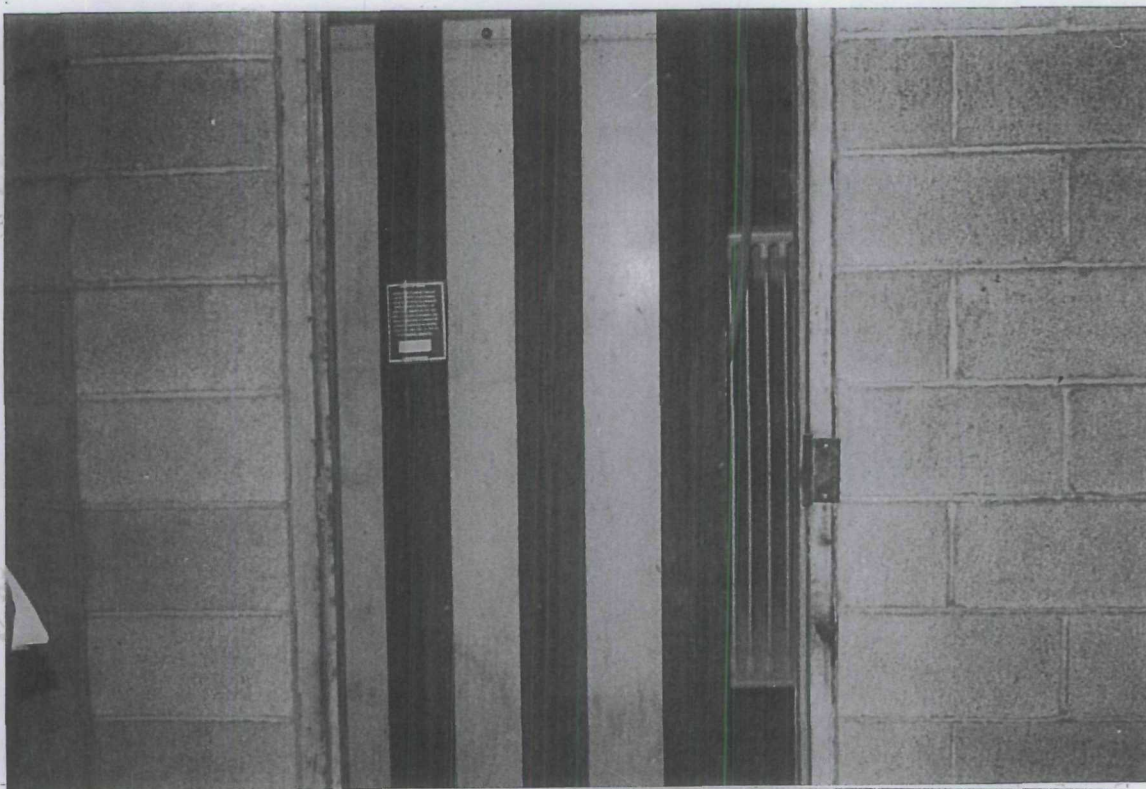
DESCRIPTION: Room 3 on the third floor of Plant J-1 was inaccessible due to large metal bars which were welded across the door frame. A blue label on one of the bars identifies the transformer in the room as containing dielectric fluid of less than 50 ppm PCBs.

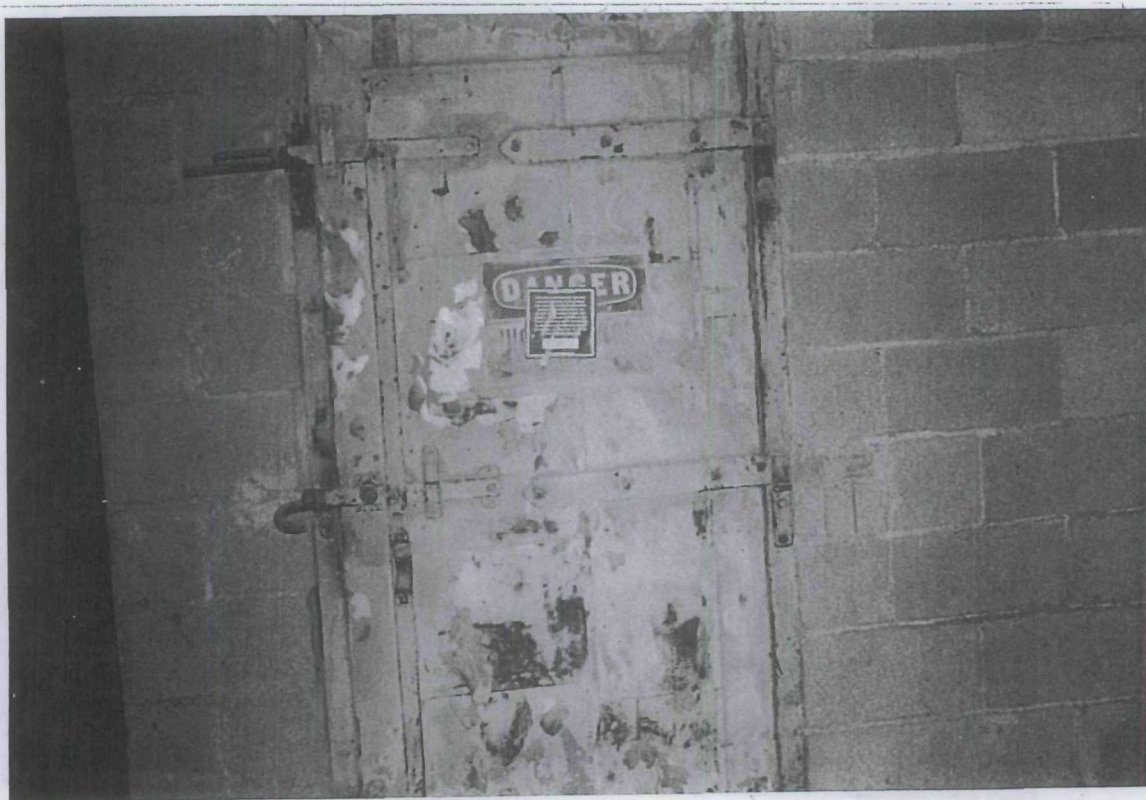
DESCRIPTION: Room 4 on the third floor of Plant J-1 was inaccessible due to the door being tack welded closed. The door was marked with the same label as the door frame of Room 3 on the third floor.

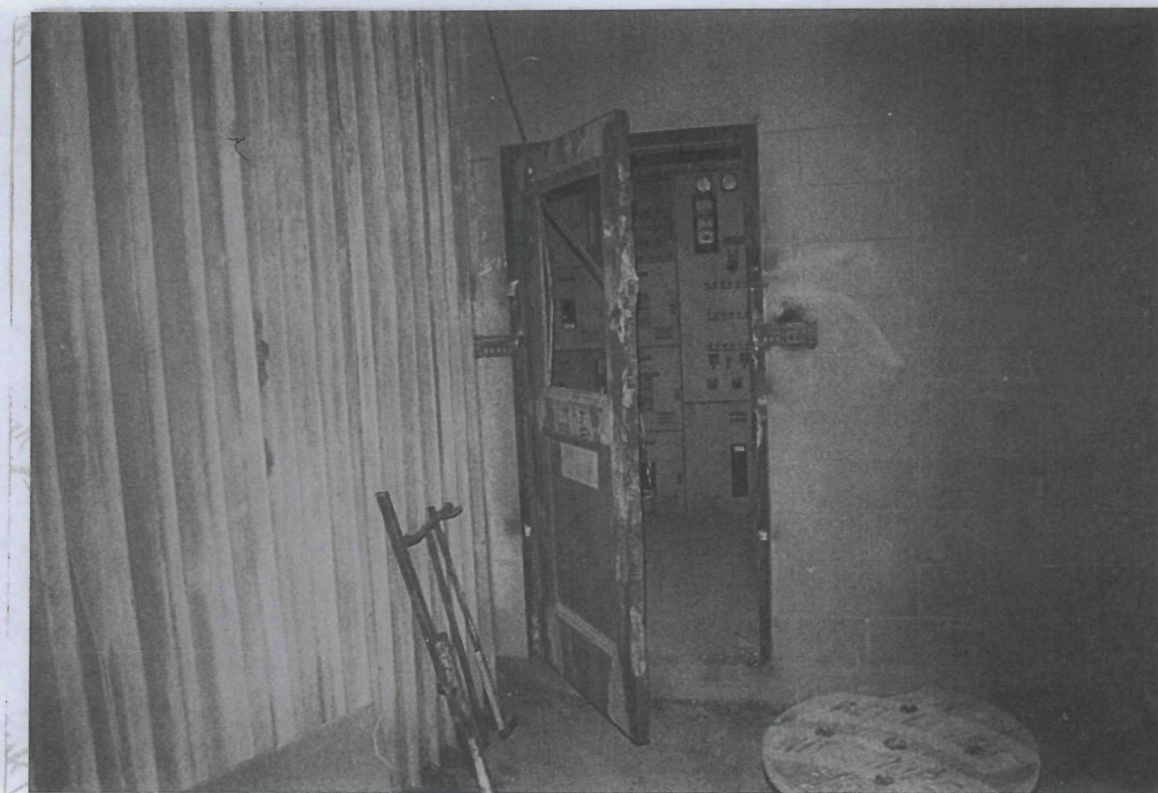
PAN: 9M0801SIXX **PHOTO:** 30
PHOTOGRAPHER: Mayer

Room 1 on the fourth floor of Plant J-2 contained the General Electric Pyranol Unit Substation Transformer, serial number C-856281. Oily residue was observed on the floor and base of the transformer on its eastern side. A floor drain was located within 5 feet from the oil residue and the eastern side of the

DESCRIPTION: Room 1 on the fourth floor of Plant J-2 contained transformer C-856281.

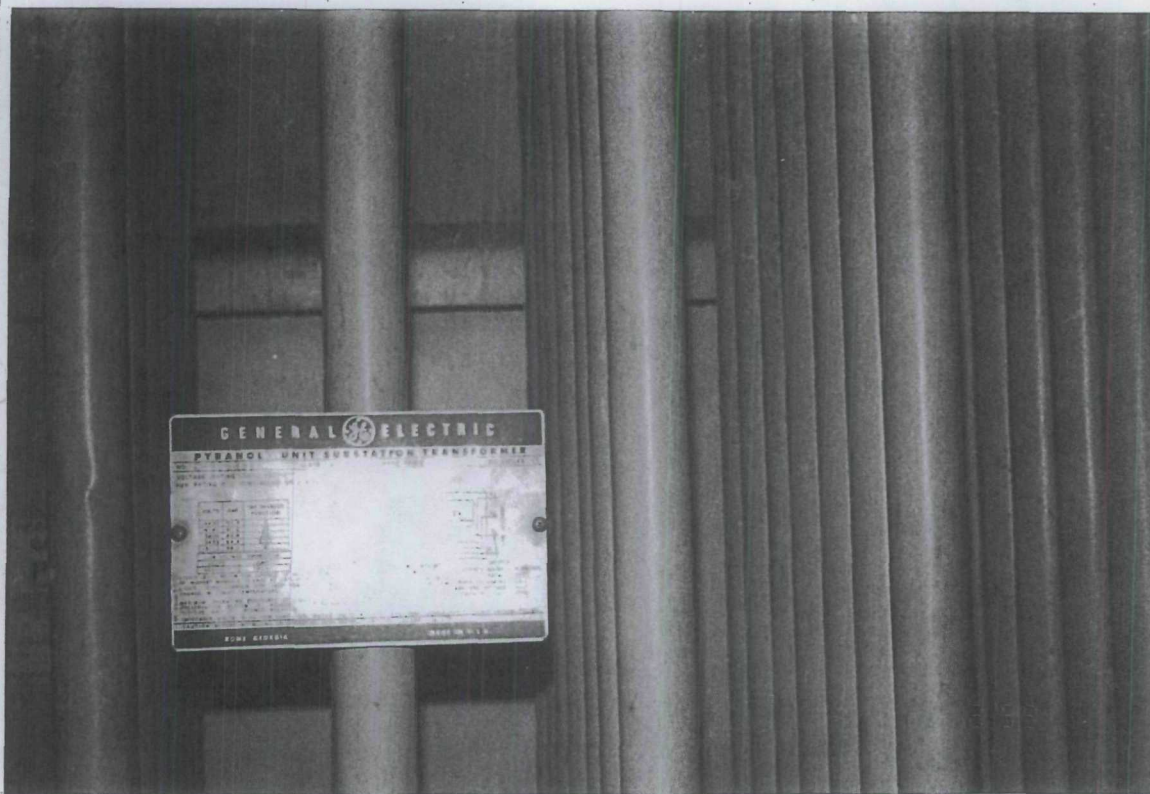
PAN: 9M0801SIXX **PHOTO:** 31

transformer. A valve on the west side of the transformer also appeared to be leaking and there was a visible oil spot on the floor below the valve. Room 2 on the fourth floor of Plant J-2 contained General Electric Transformer, serial number L-249412. The lower valve on this transformer appeared to be leaking oil onto the floor. START also observed a 1 to 2 inch layer of fine dust on the floor under the leaking valve which also had a considerable amount of oil residue in it. Room 3 on the third floor of Plant J-2 was not accessible due to the door being welded shut. The door was marked with a blue label indicating that the dielectric fluid in the unit contained less than 50 ppm PCB and was therefore classified as a non-PCB. According to the security personnel, a room is located on an upper level of Plant J-2 and believed to also contain a transformer. However, access to this room is not possible due to missing stairways to that upper level and the room is not accessible by any other level. This area will be referred to as Room 4 of Plant J-2.

DESCRIPTION: Oil residue was observed to have leaked from the base of transformer C-856281. A floor drain was within five feet of this oil residue.

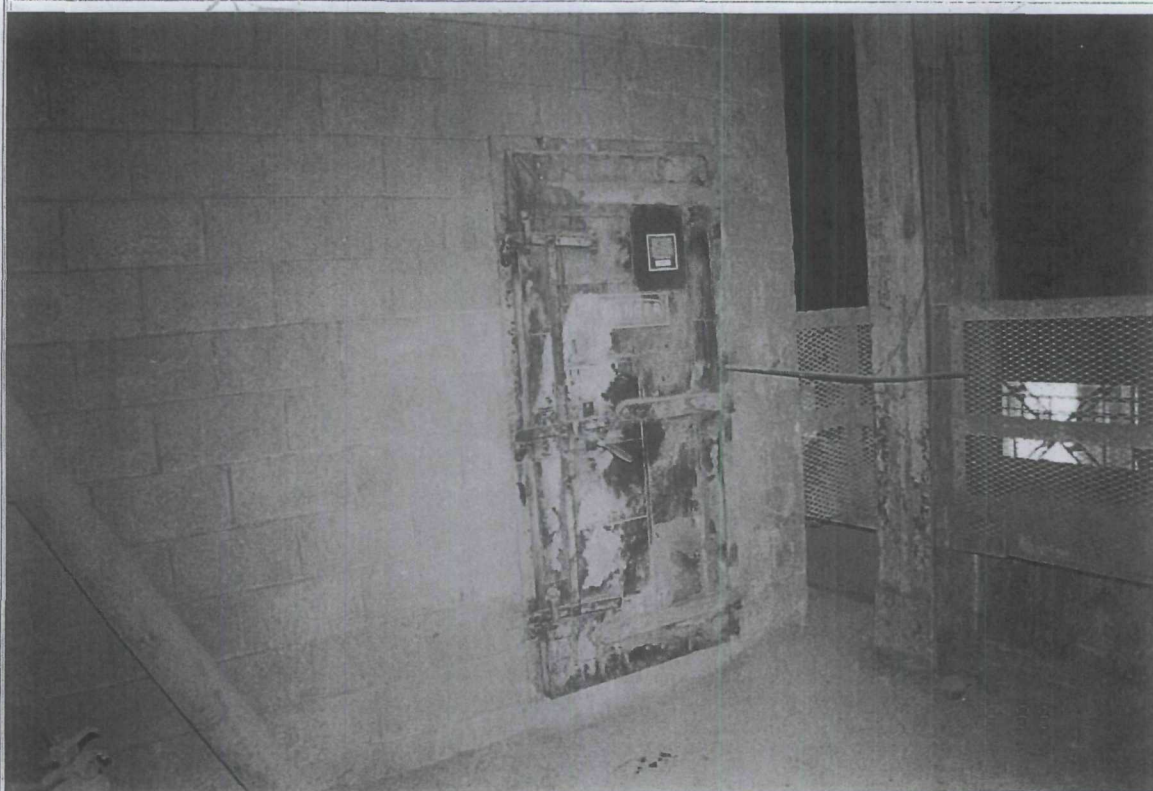
PAN: 9M0801SIXX **PHOTO:** 36

DESCRIPTION: Room 3 on the third floor of Plant J-2 was inaccessible due to being tack welded closed. The door was marked with a label indicating that the dielectric fluid in the unit was tested and determined to contain less than 50 ppm PCBs.

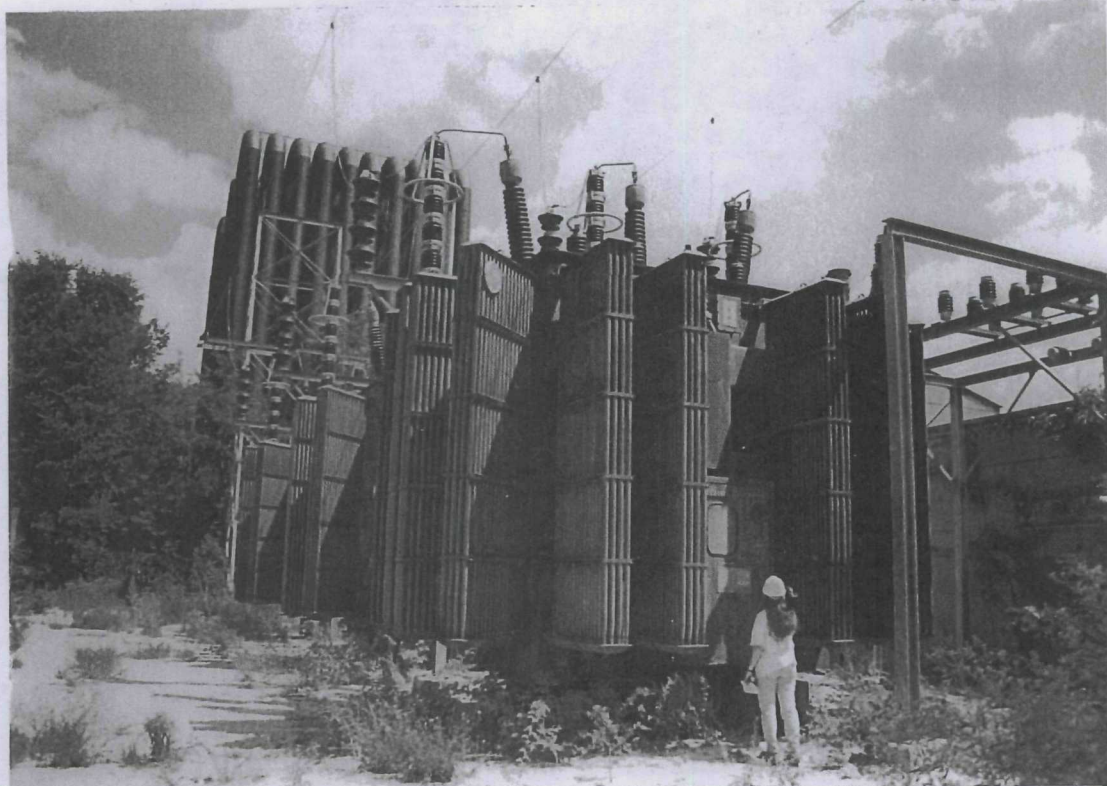
SITE: Jefferson Processing Site **TDD:** S05-9903-008 **PAN:** 9M0801SIXX **PHOTO:** 37
DIRECTION: Northeast **DATE:** 8/11/99 **PHOTOGRAPHER:** Bowerman
DESCRIPTION: This is an overview of the three transformers located at the outdoor substation area on site.

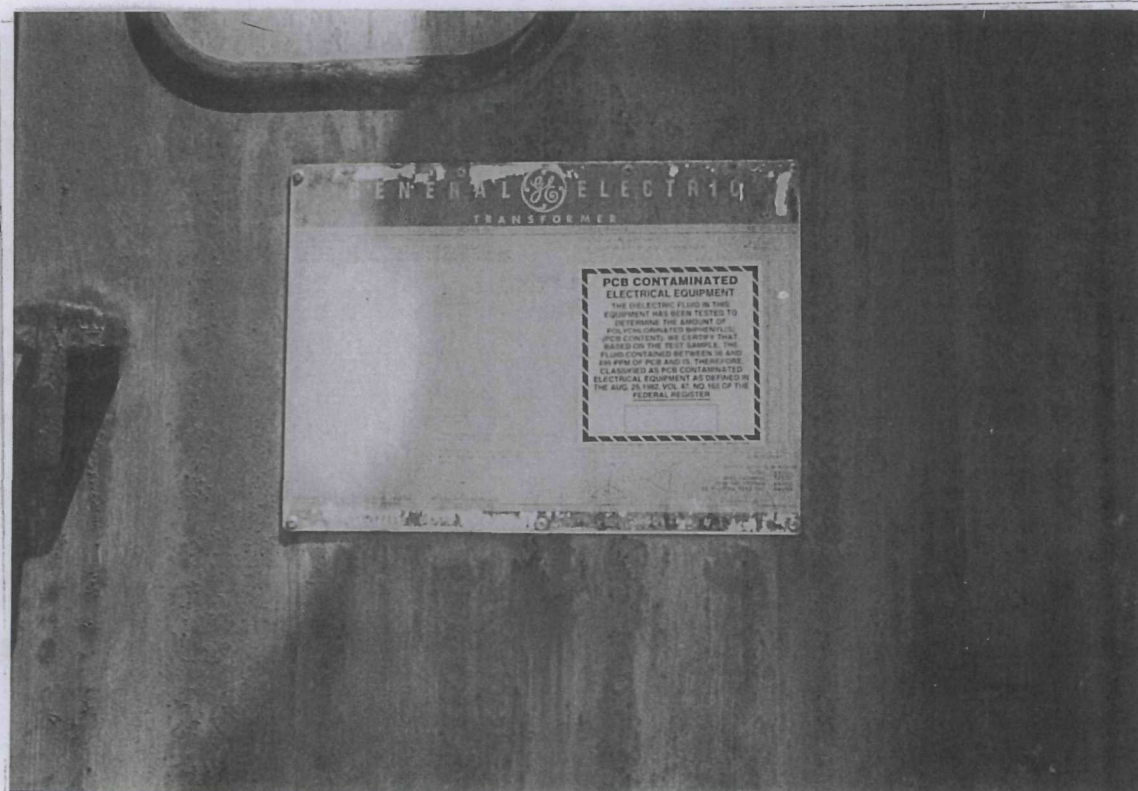
Three transformers were observed in a fenced outdoor substation located on the northwest side of Plant J-1. General Electric Transformer, serial number C-657612, was marked with a caution label identifying it as PCB-contaminated electrical equipment that contained dielectric fluid consisting of 50 to 499 ppm PCBs. The cooling pipes were observed to be rusted. Gravel and soil beneath sections of cooling pipes were also observed to be discolored. General Electric Unit Substation Transformer, serial number C-656341 was marked with a label identifying it as containing PCBs. General Electric Unit Substation Transformer, serial number C-656340 was marked with a caution label identifying it as PCB-contaminated electrical equipment that contained dielectric fluid consisting of 50 to 499 ppm PCBs. A drip of liquid was observed to be suspended from a plug underneath a section of cooling pipes. One side of the transformer was also discolored, as was a section of the soil and gravel below the transformer.

SITE: Jefferson Processing Site **TDD:** S05-9903-008 **PAN:** 9M0801SIXX **PHOTO:** 38
DIRECTION: Northeast **DATE:** 8/11/99 **PHOTOGRAPHER:** Mayer
DESCRIPTION: Transformer C-657612 located in the outdoor substation area was observed to be marked with a label stating that it was "PCB Contaminated Electrical Equipment."

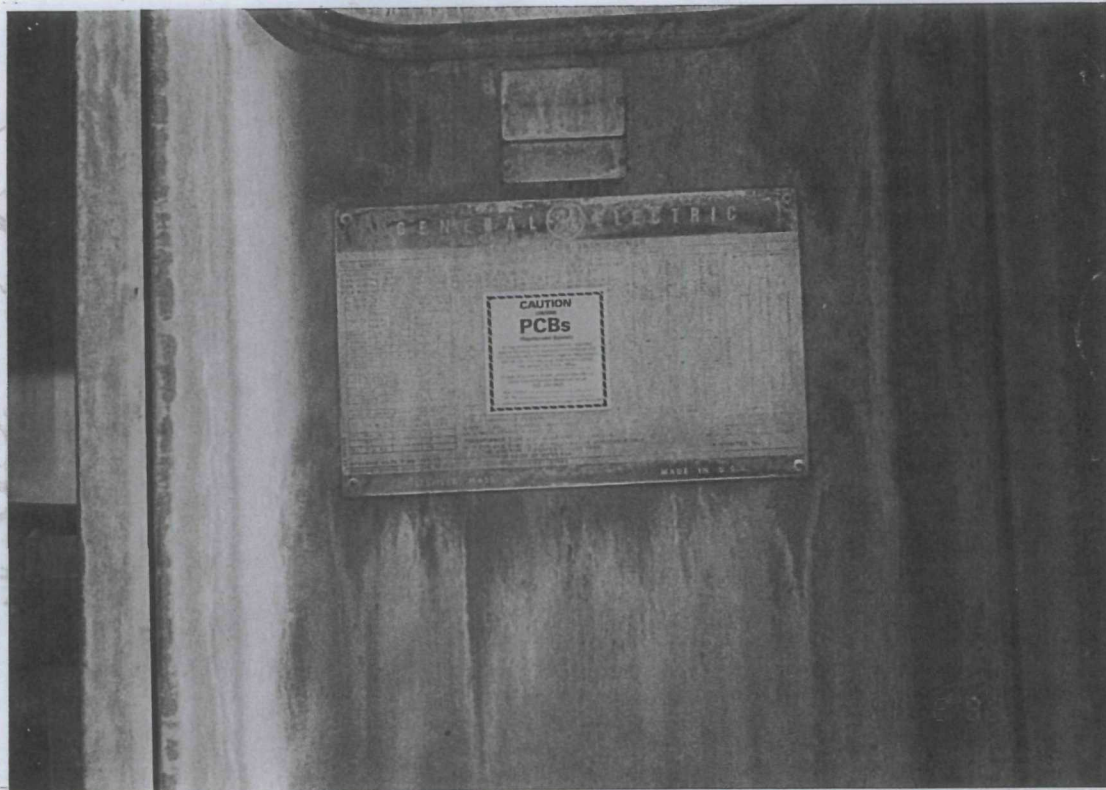
PAN: 9M0801SIXX **PHOTO:** 41
PHOTOGRAPHER: Mayer

DESCRIPTION: Transformer C-656341 located in the outdoor substation area was observed to be marked with a yellow caution label stating that it contained PCBs.

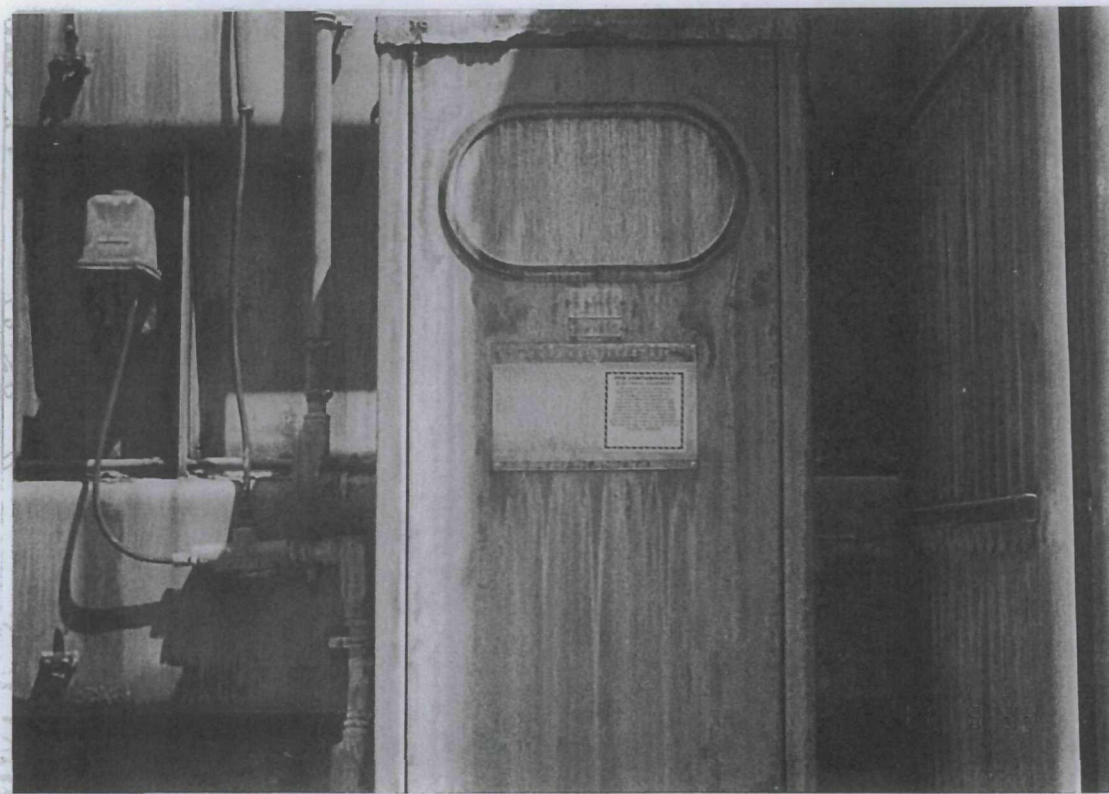
PAN: 9M0801SIXX **PHOTO:** 42
PHOTOGRAPHER: Mayer

DESCRIPTION: Transformer C-656340 located in the outdoor substation area was observed to be marked with a label stating that it was "PCB Contaminated Electrical Equipment."

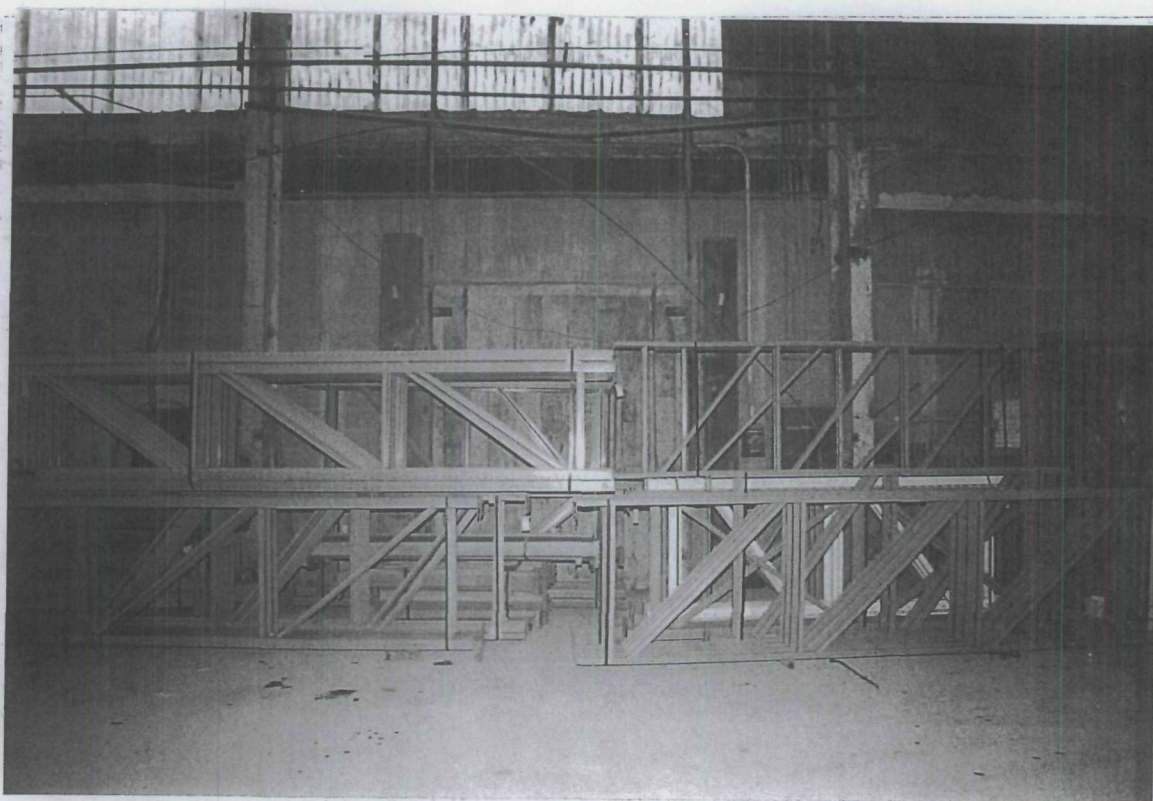
DESCRIPTION: The main access door into Room 1, Plant J-1, was closed and bundles of metal frames were moved in front of the door to prevent entrance. The door can only be opened with the use of a tow motor due to the weight of the door.

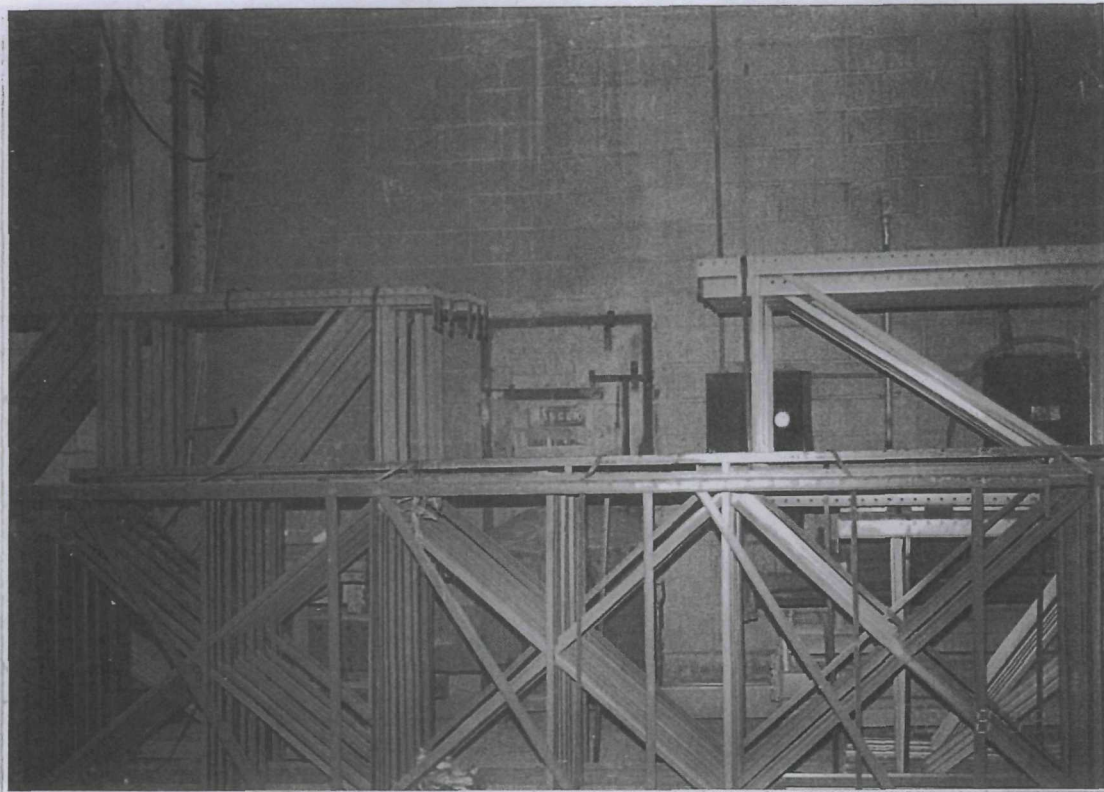
PAN: 9M0801SIXX **PHOTO:** 49

DESCRIPTION: A second door into Room 1, Plant J-1, had been previously tack welded closed. A cement block weighing approximately two tons and several bundles of metal frames were placed in front of the door to prevent access the door.

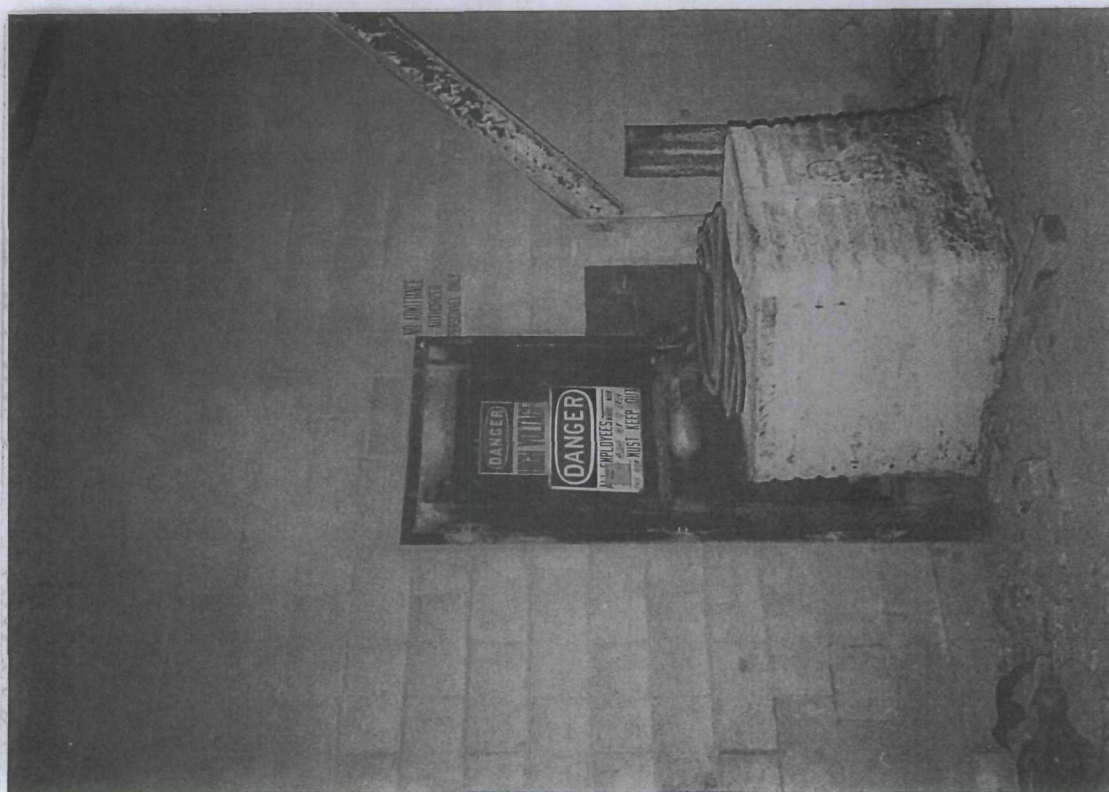
PAN: 9M0801SIXX **PHOTO:** 50

DESCRIPTION: The door to Room 2, Plant J-1, was pinned closed by a block of cement which weighed approximately two tons in order to prevent entrance.

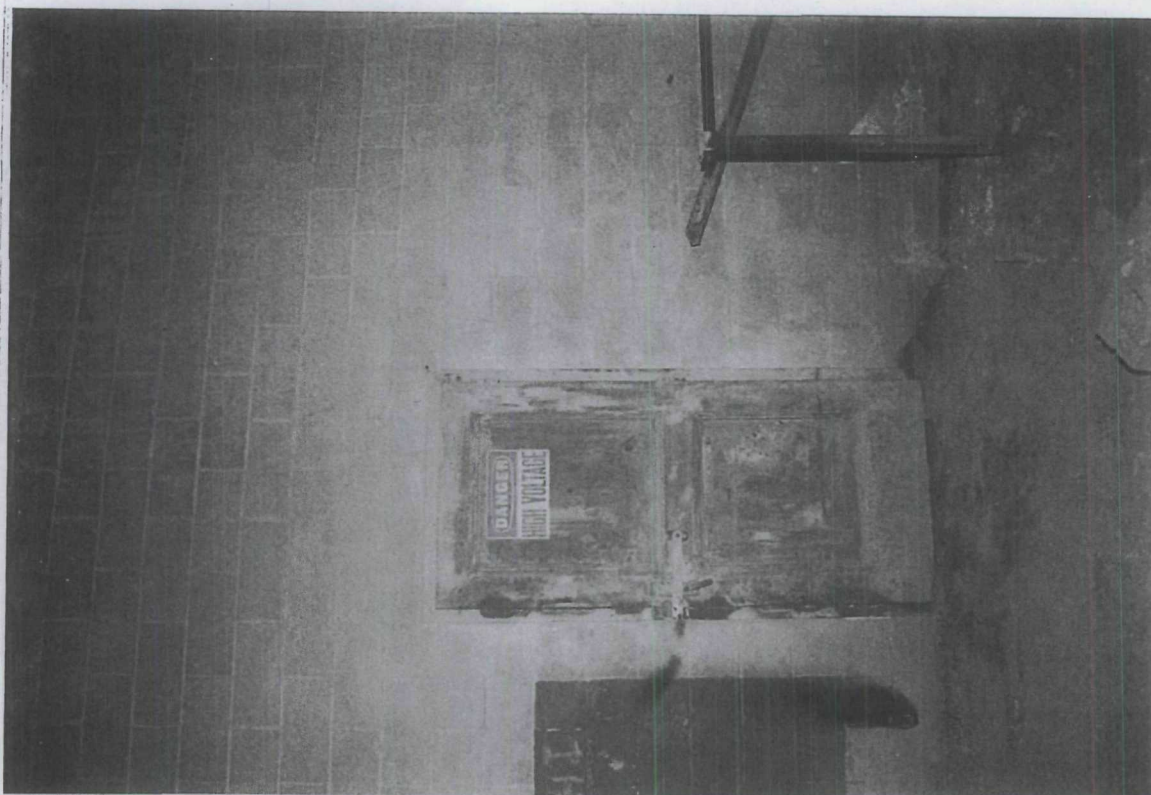
PAN: 9M0801SIXX **PHOTO:** 51

DESCRIPTION: The first door into Room 5, Plant J-1, appeared to have been tack welded closed to prevent entrance.

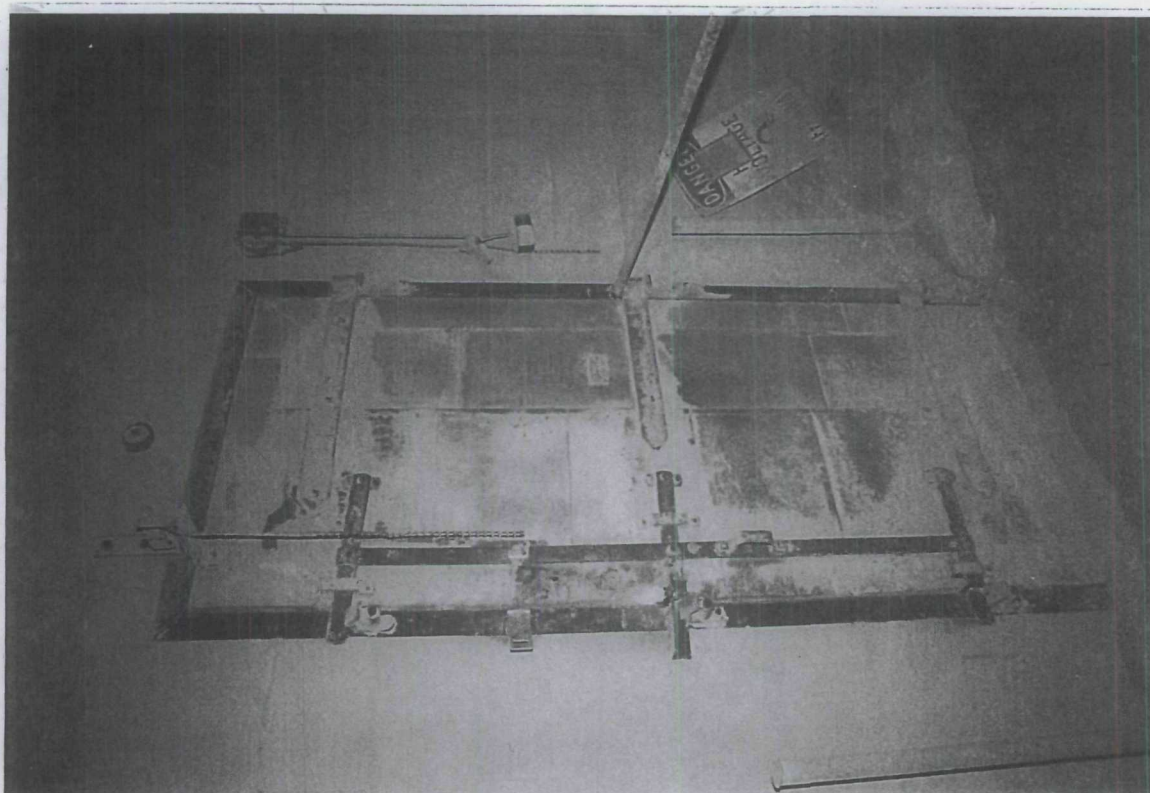
PAN: 9M0801SIXX **PHOTO:** 52

DESCRIPTION: The door to Room 6, Plant J-1 appeared to have been tack welded closed to prevent entrance.

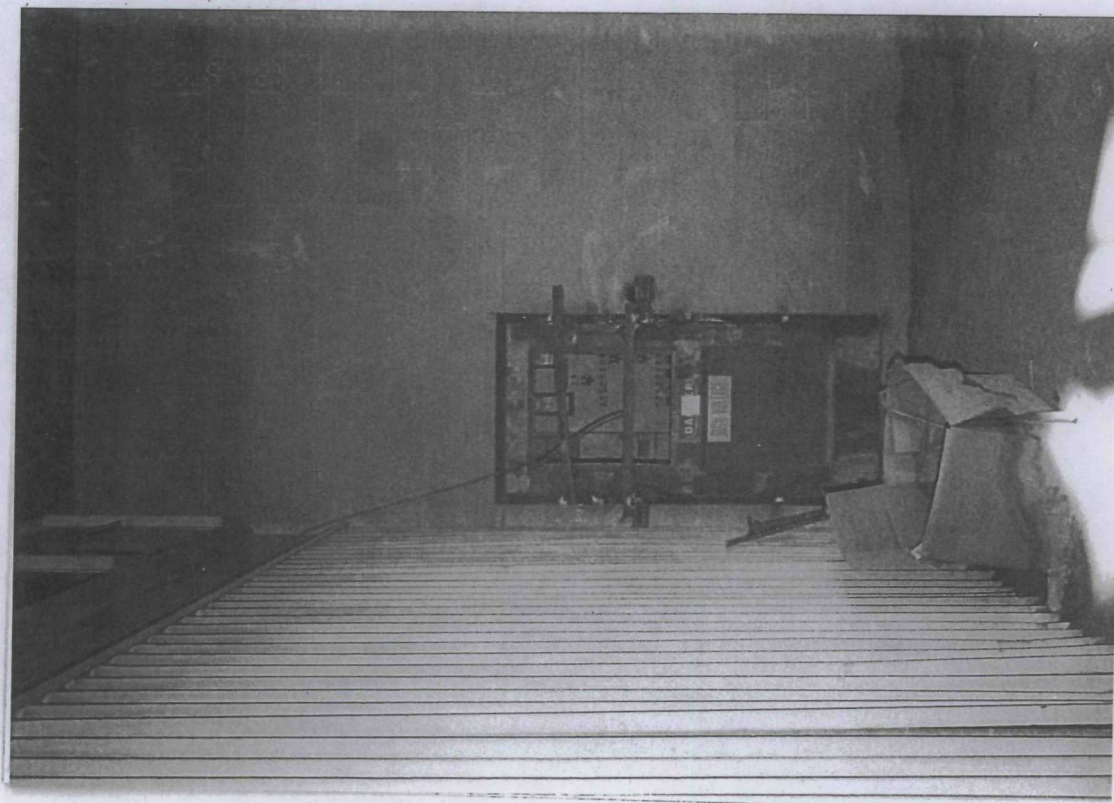
PAN: 9M0801SIXX **PHOTO:** 53
PHOTOGRAPHER: Mayer

DESCRIPTION: The door to Room 1, Plant J-2, appeared to have been tack welded closed to prevent entrance. Two metal bars had also been welded across the open window in the door.

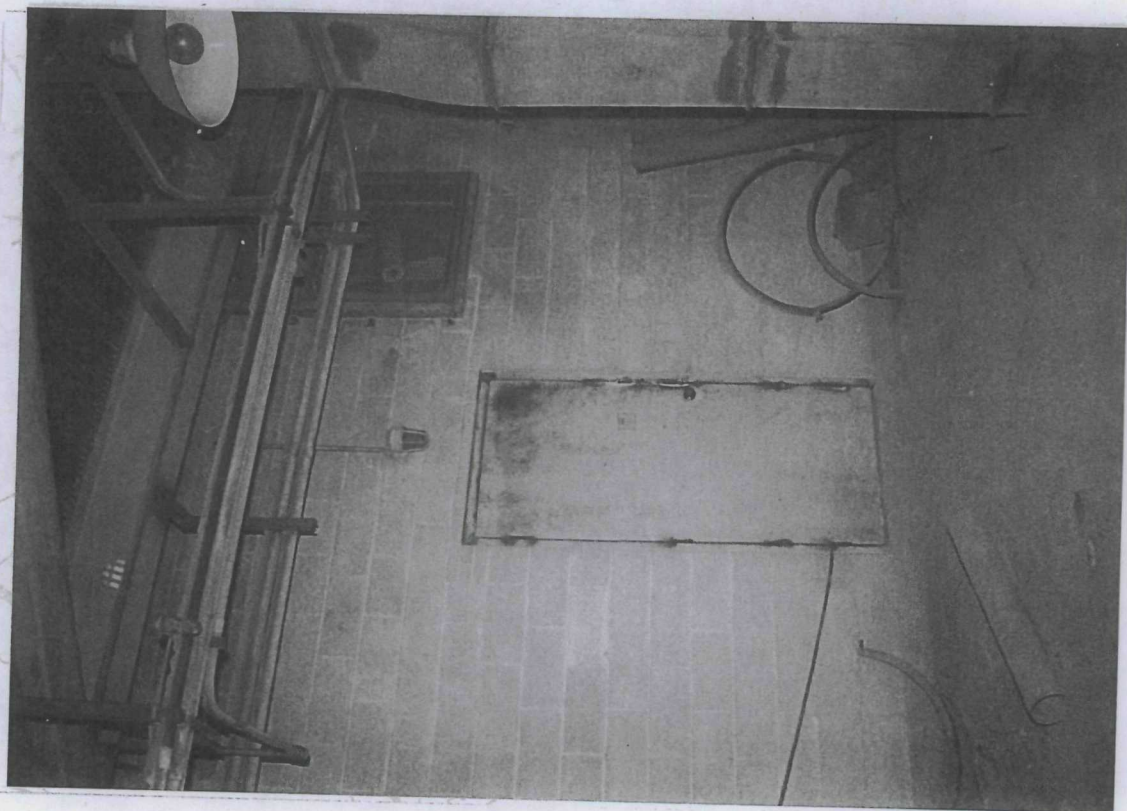
PAN: 9M0801SIXX **PHOTO:** 54
PHOTOGRAPHER: Mayer

DESCRIPTION: The door to Room 2, Plant J-2, appeared to have been tack welded closed to prevent entrance.

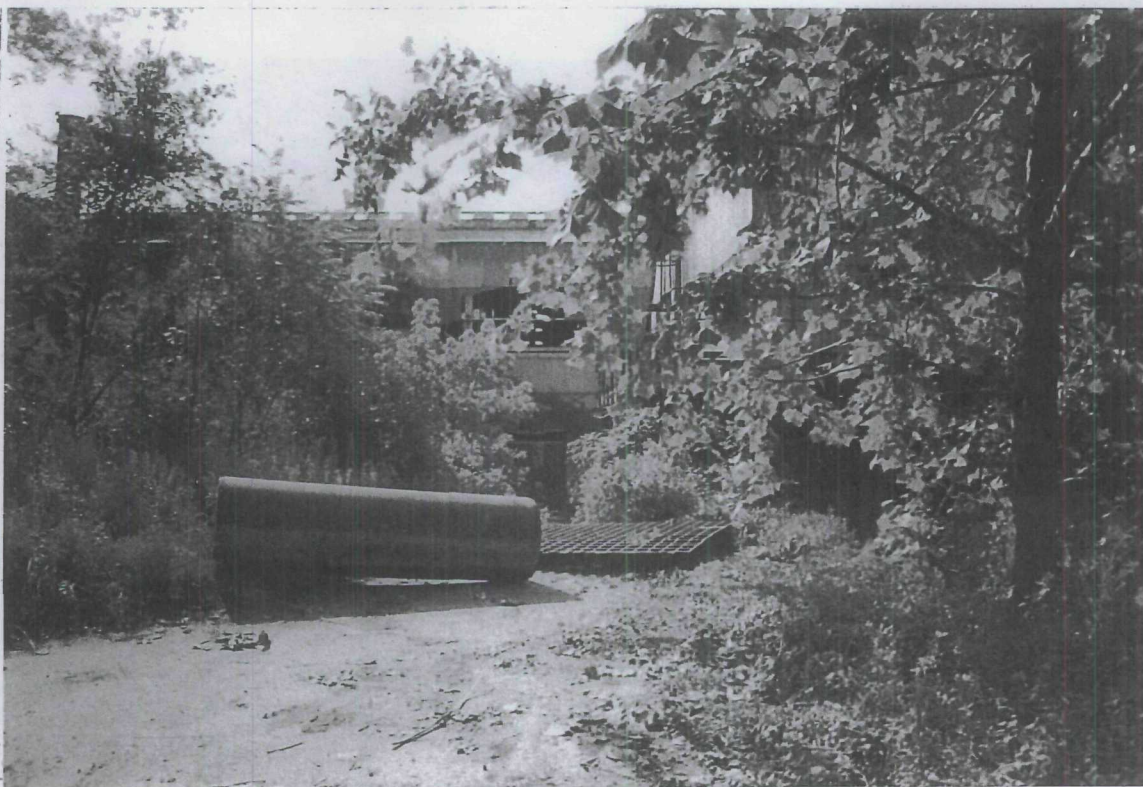
PAN: 9M0801SIXX **PHOTO:** 55

DESCRIPTION: A large metal cylinder and metal grate had been positioned across the top of the vehicle access path to an unsecured bay door on the northwest side of Plant J-1. Both metal items required heavy equipment to be moved.

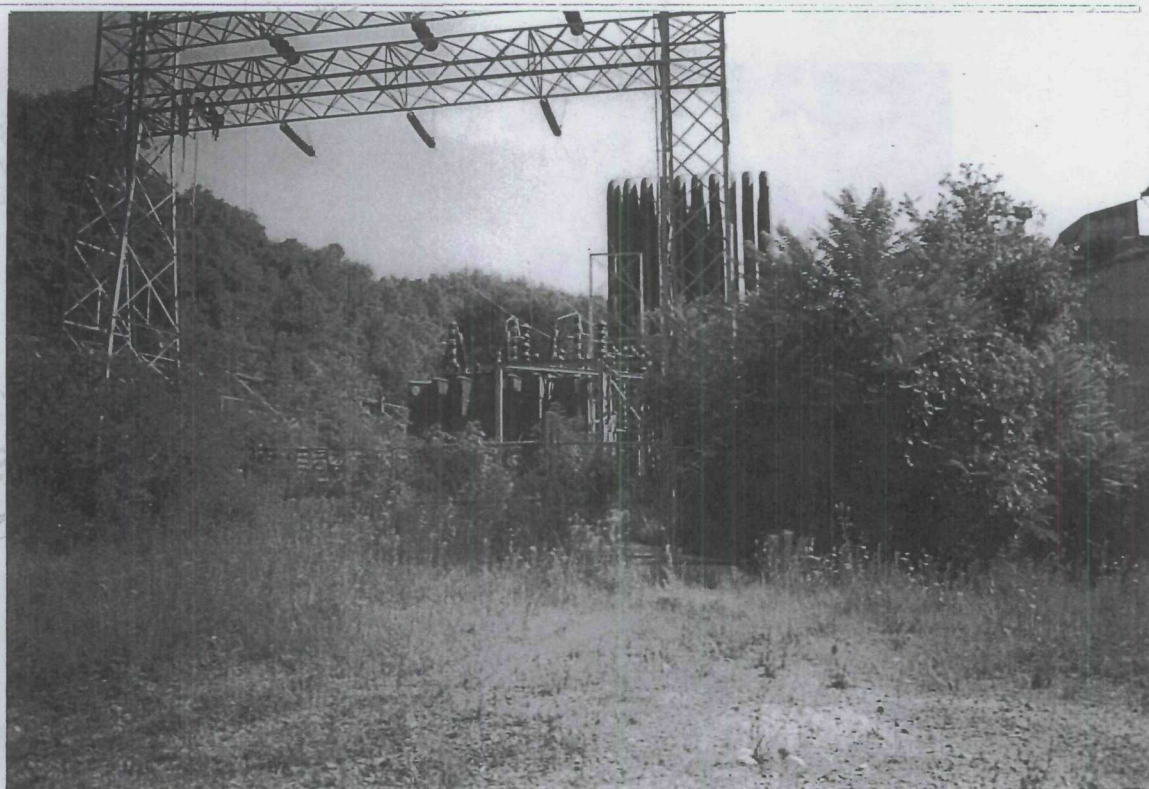
PAN: 9M0801SIXX **PHOTO:** 56

DESCRIPTION: The gates to the outdoor substation area were closed. However, there was no locking mechanism on the gates to secure them.

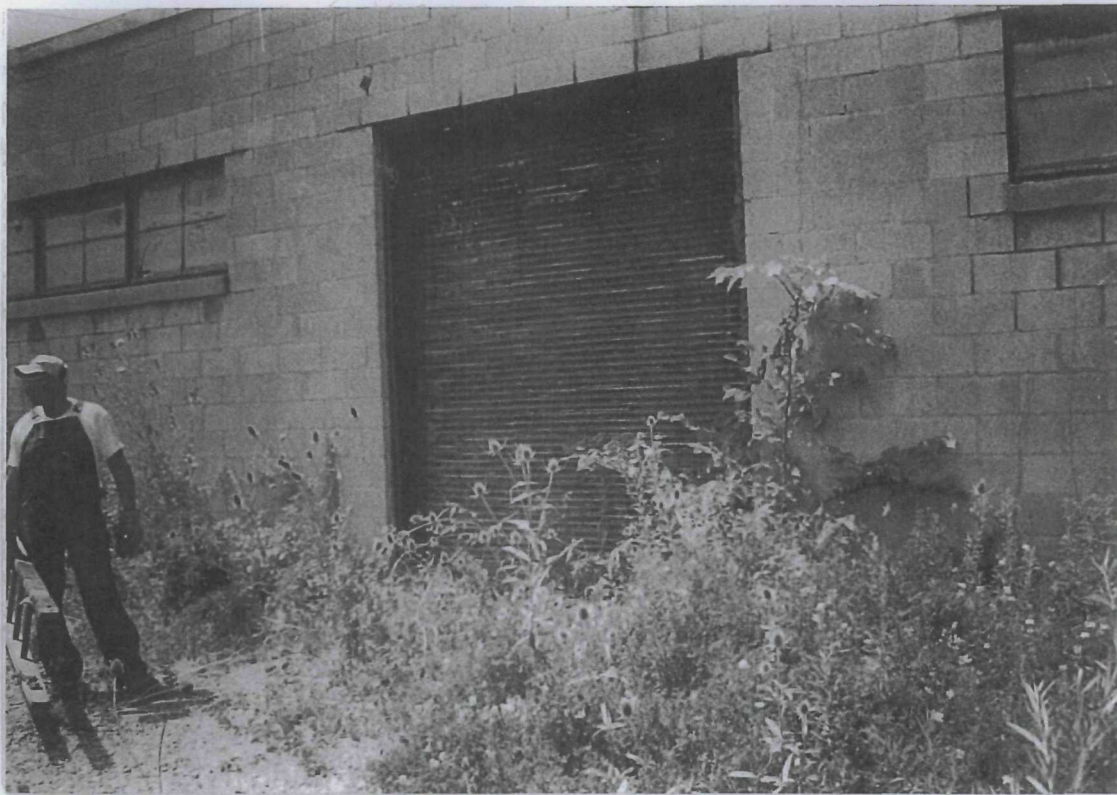
DESCRIPTION: The metal overhead bay door on the southeast side of the Pumphouse appeared to be secured. It can only be accessed from the inside by using a pulley to open the door.
